*F*ATAL

Never work between an unsecured forklift mast and frame

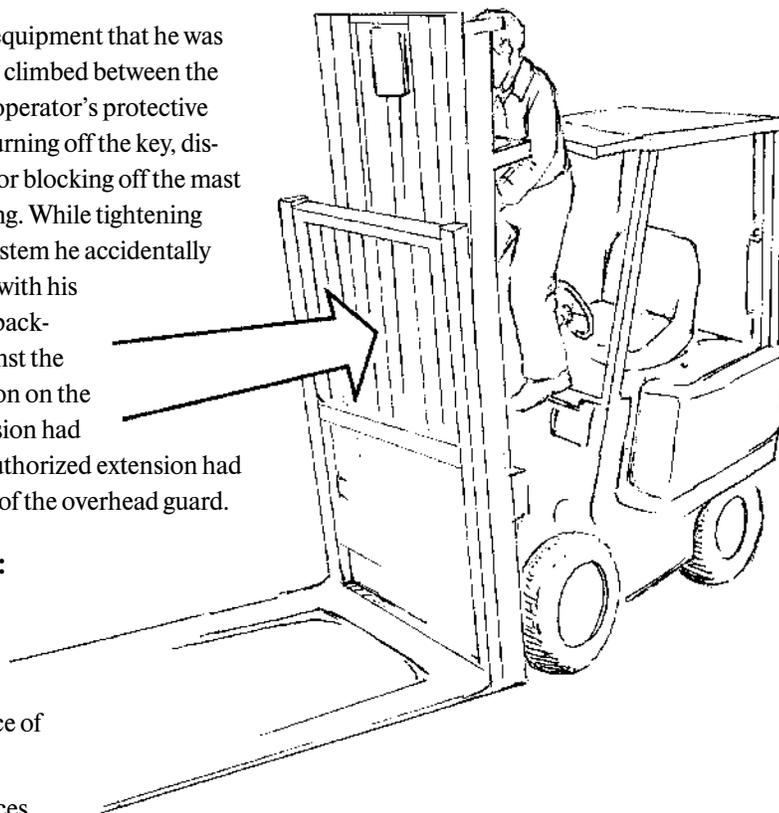
A mechanic was crushed between the mast and frame of a forklift truck that he was servicing. He died from internal injuries shortly after the accident. An investigation concluded that the following sequence took place prior to the accident.

To reach the hydraulic equipment that he was servicing, the mechanic climbed between the mast assembly and the operator's protective structure without first turning off the key, disconnecting the battery, or blocking off the mast to prevent it from moving. While tightening parts of the hydraulic system he accidentally hit the tilt-mast control with his foot. The mast jumped backward crushing him against the overhead guard extension on the frame. The guard extension had been modified. An unauthorized extension had been added to the front of the overhead guard.

• Ensure that all workers receive adequate instruction in the safe performance of their duties.

• Lock out control devices and secure all parts of equipment (block out) against inadvertent movement before servicing equipment.

• Maintain mobile equipment in safe operating condition and ensure that all modifications are carried out in accordance with the manufacturer's instructions.
